# Chinese Barrel Evaluation

June 15, 2018

## Executive Summary

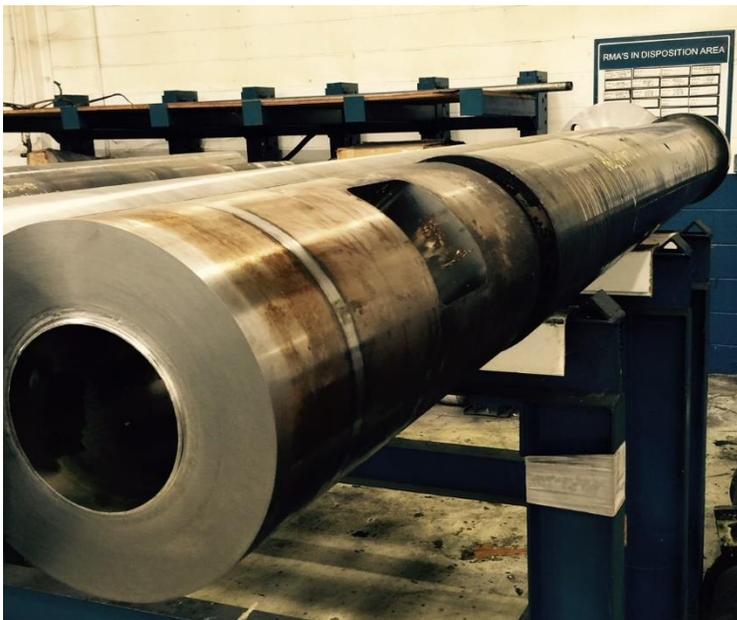
135mm Injection Barrel

Molders Services has requested a full analysis on a competitor's barrel imported from China. This barrel was sent to us for evaluation after a premature failure was experienced due to excessive wear in the ID. The 135mm injection barrel was sold as having a high wear Tungsten Carbide bimetallic inlay comparable to the Xaloy 800 product. After receiving the barrel, we cut off 6" from the end and prepared multiple samples for analysis including inlay chemistry, backing steel chemistry, physical properties, abrasion resistance and barrel construction methods. Results from every test showed the Chinese barrel to not only be inferior to the performance characteristics of the X800 (Tungsten Carbide) inlay, but also inferior to the X102 (standard bimetallic) inlay.

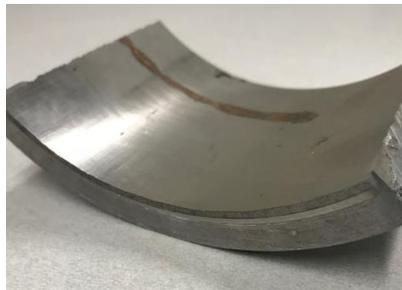
*Specimen from Imported Barrel which was a thin walled liner pressed into a housing*

The chemistry of the sample barrel is measured with our Oxford X-met metal analyzer. Three spots at different locations of the barrel were measured and listed below. There is no tungsten carbide in this inlay and a very low hardness. Clearly, the imported barrel is nothing close to a high-performance abrasion and corrosion resistant inlay as in the X800 as it was represented to the customer. We can say the same to its performance compared to the Xaloy X102. The relatively high nickel and low iron content give it very low hardness properties and very poor abrasion resistance.

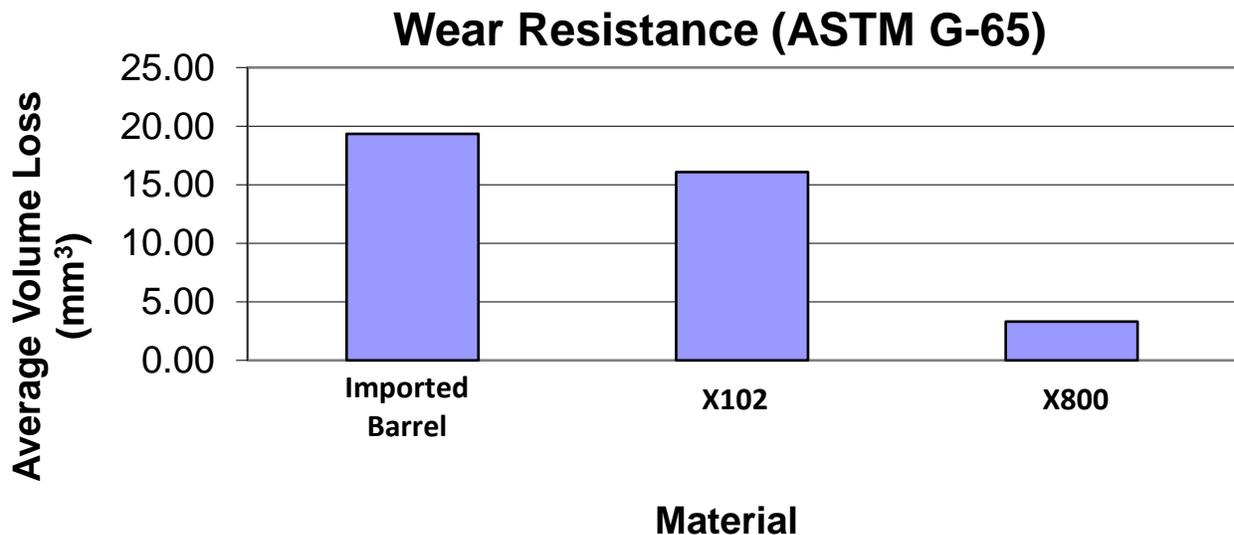
Specimens were cut from the barrel and run through the industry standard ASTM G65 abrasion test. This is a test that forces a spinning rubber wheel against the sample specimen while sand is fed between the two. Essentially grinding sand or abrading it against the bimetallic inlay sample. After a given number of cycles the volume of inlay removed by the sand is recorded. There are 3 samples run for each inlay to reach an average wear. The chart below shows the volume loss of all 3 inlays: X800, X102 and the imported barrel.

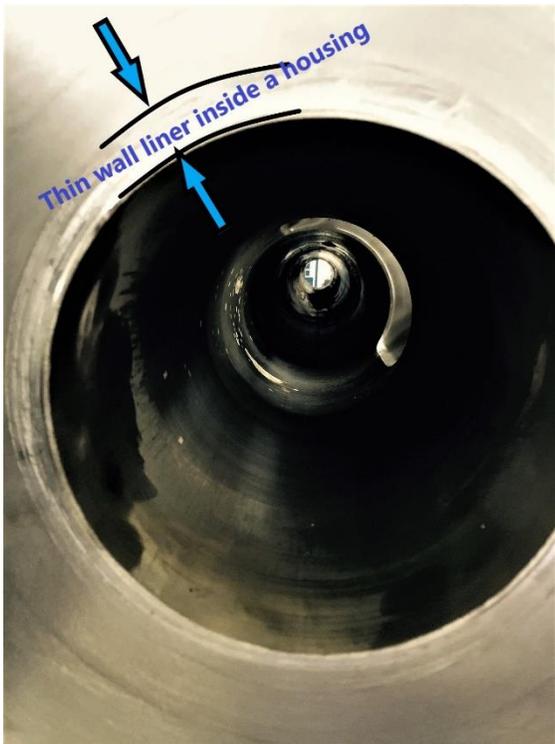
The last 6" of the barrel was cut off to run all these tests, after which it was clear there was a thin wall bimetallic liner pressed inside a housing. This is an unacceptable method to construct a barrel of this size.

There are many well documented problems with this method. The strength of the barrel is now compromised as compared to a single piece construction method. The thermal heat transfer from the outside heater bands to the melt stream inside the barrel has now been reduced since there are gaps between the liner and housing.

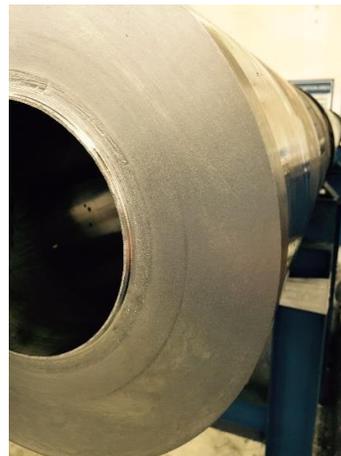
Additionally, there is a high risk of molten plastic getting between the liner and housing through thermocouple holes and discharge barrel end face that is under high pressure. These are all common problems associated with poorly constructed barrels.
